Manhole Inspection Summary

Manhole # S09CC2003MH

Insp Date: **7/18/06 8:19 AM**

Location Address: **2412 ROCKWOOD AVE**

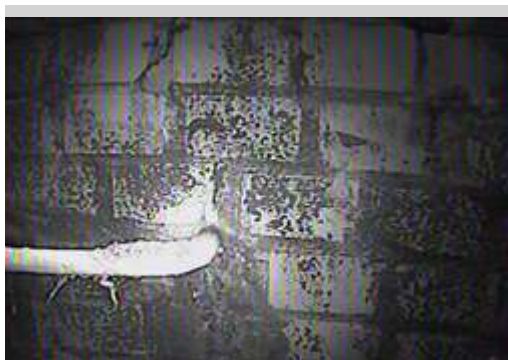
Defect

Barrel infiltration.

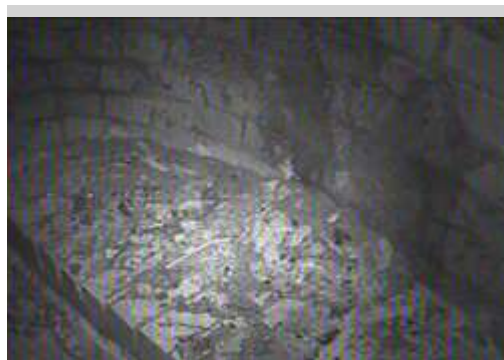
Defect

Bench debris. Barrel infiltration.

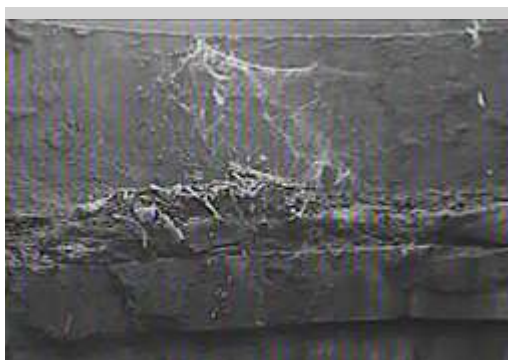
Defect

Infiltration: ☐ None ☒ **Joint** ☐ Cracks ☒ **Mortar** ☐ Roots ☐ Wall

Adjustment infiltration

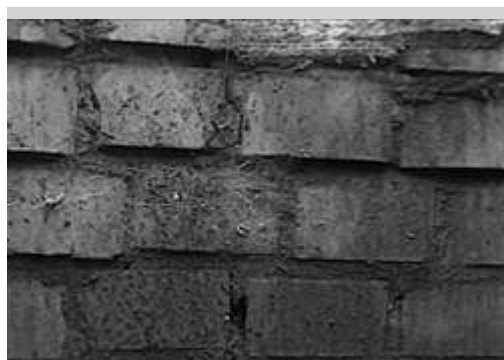
Defect

Infiltration: ☐ None ☐ Joint ☐ Cracks ☒ **Mortar** ☐ Roots ☐ Wall

Corbel infiltration.

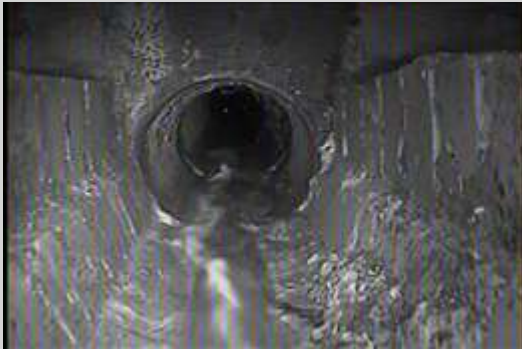
8 in. Circular Gravity Sewer Pipe Out @ 12 O'Clock

Infiltration: **Evidence** Pipe Seal Cond: **Unknown**

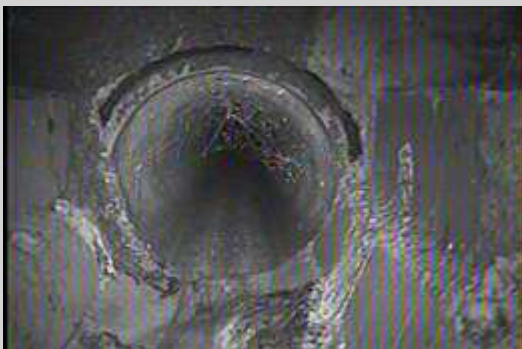
8 in. Circular Gravity Sewer Pipe In @ 6 O'Clock

Infiltration: **Evidence** Pipe Seal Cond: **Unknown**
